# **Inspection Report**

Property Address: XXXX S StreetName St Denver CO 80219

A Healthy Home, LLC

Date: 5/2/2017 Time: 09:00 AM Report ID: 93xx

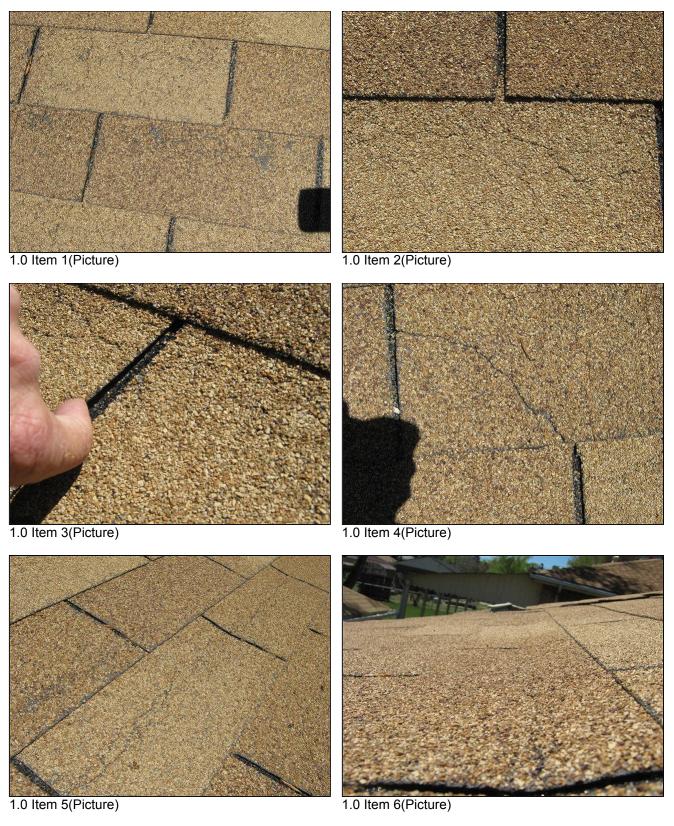
**1.0** Roof covering is old and may have less than 4 years of life remaining. Recommend having a roofing company inspect and make repairs as necessary. The shingles along the transition to the patio roof are showing surface cracking. Other areas of the roof also have cracking and are starting to loose their adhesion. Once this begins the roof's ability to shed water diminishes quickly. The roof is a hip style with a shed roof over the back patio.

Roof covering over the patio was installed over the previous roof. There are 2 layers of roofing over the patio and it has more cracking visible than other areas of the roof. 3 layers are not allowed, so the coverings will need to be removed when the next roof is installed. Roofing over an installed layer may violate the shingle manufactures warranty.

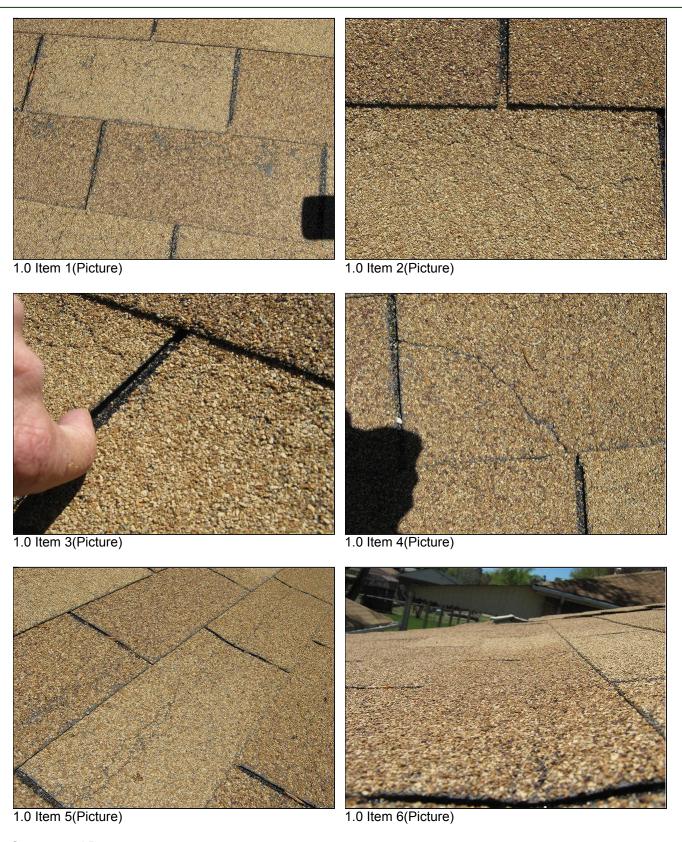
## 1. Roof

Roof covering is old and may have less than 4 years of life remaining. Recommend having a roofing company inspect and make repairs as necessary. The shingles along the transition to the patio roof are showing surface cracking. Other areas of the roof also have cracking and are starting to loose their adhesion. Once this begins the roof's ability to shed water diminishes quickly. The roof is a hip style with a shed roof over the back patio.

Roof covering over the patio was installed over the previous roof. There are 2 layers of roofing over the patio and it has more cracking visible than other areas of the roof. 3 layers are not allowed, so the coverings will need to be removed when the next roof is installed. Roofing over an installed layer may violate the shingle manufactures warranty.

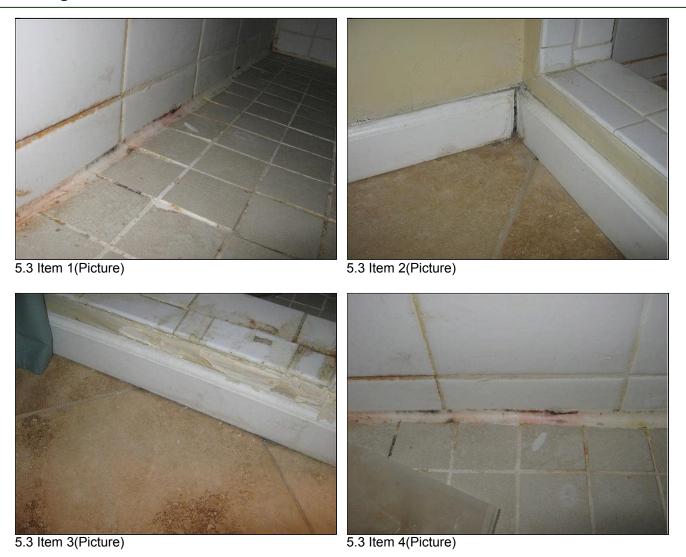
(1) Basement shower is in poor condition and needs repairs. Mold and bacteria deposits are visible of the caulk and in the grout lines. Significant cracks have appeared in the grout that are allowing moisture to get behind the tiles and into the wall. Moisture was detected under the floor tiles using a protimeter (moisture meter). Considering the condition of this shower I would expect toxic molds to be present behind the tiles and inside the walls surrounding the shower. The shower needs to be remediated by a certified mold expert using IICRC S520 standards. Precaution should be taken to control the spores during the remediation efforts. Containment with negative air pressure needs to be set-up in the bathroom to control the spores. The bottom 2 row of tile need to be replaced. The backing board will also need to be replaced in places. Mold inside the wall needs to be removed. Drywall that has visible mold must be replaced. Wood that has mold visible on it needs to be cleaned and/or sanded down, HEPA vacuumed and treated with an antimicrobial coating. Wood that is rotted needs to be replaced. Once the mold is removed, the remediation area needs to be HEPA vacuumed with walls and smooth surfaces damp wiped. The air needs to be cleaned using HEPA air scrubbers. Follow up testing is recommended by in Independent Environment Professional.
